### Case Study

## University of Oklahoma Warehouse, Norman, OK

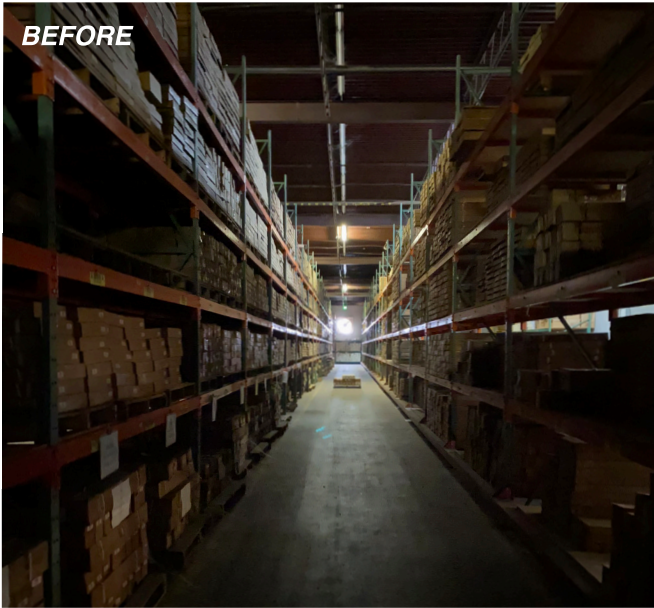
**BEFORE**

- The space was so dark that temporary lights had to be used.
- Three large rooms within the warehouse had no working lights at all.
- The existing lighting had no controls, and the wiring and conduit were obsolete.

- Remove the existing high pressure sodium and fluorescent fixtures.
- Replace obsolete wiring and conduit per code.
- Install new LED high bay and emergency backup fixtures with integrated occupancy sensors.

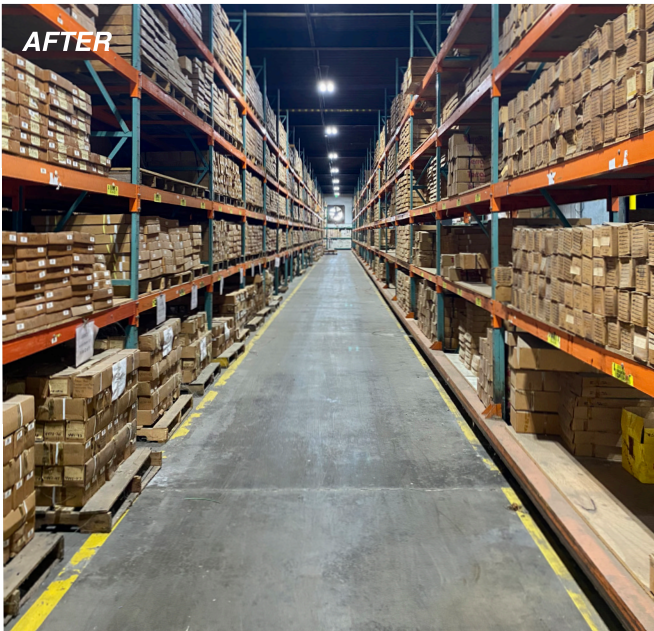
**AFTER**

- Incredibly even light distribution in all aisles of the warehouse with about \$6K per year in energy savings
- Updated wiring and conduit to last for years to come
- Lighting that shuts off when not in use and illuminates paths of egress during power outages
- Approximately \$6000 per year in energy savings
